AGENZIA NAZIONALE PER LA SICUREZZA DEL VOLO

FINAL REPORT

**ACCIDENT INVOLVED AIRCRAFT
BOEING MD-87, registration SE-DMA
and CESSNA 525-A, registration D-IEVX
Milano Linate airport
October 8, 2001**

N. A/1/04

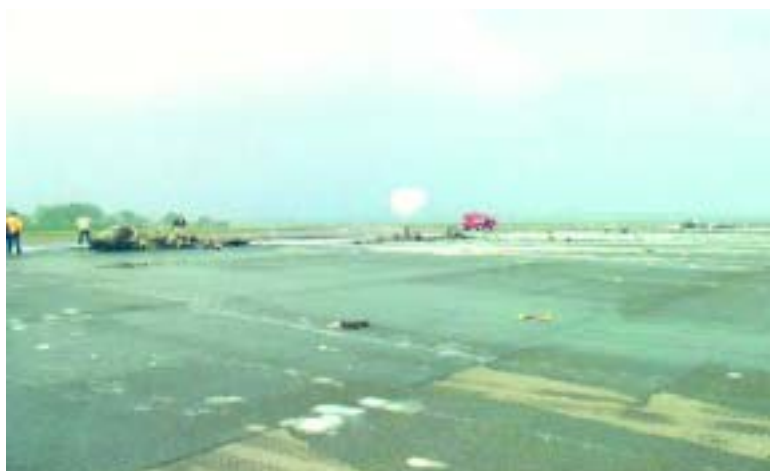
Both horizontal stabilizers were separated from the empennage

Photograph 4 – The Cessna wreckage on the runway.

and were lying on the runway. The major part of the RH elevator remained connected to the RH stabilizer. The LH stabilizer and elevator showed signs of collision on their lower side.

The LH wing did not show collision damage but it was heavily damaged by fire. Control surfaces of the LH wing were not found.

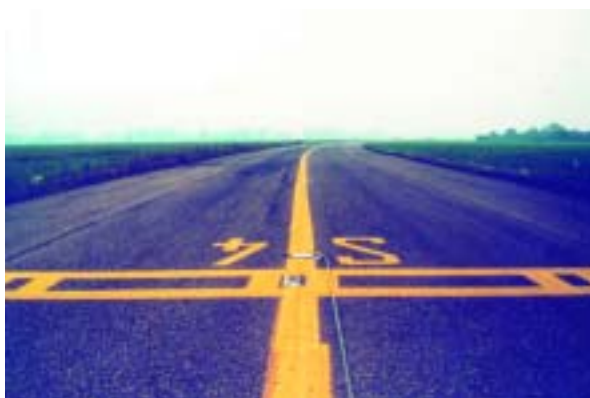
Photograph 9 - S4 marking and ICAO pattern B runway - holding.

No documentation was found signaling the existence of/or regulating the operational intended meaning of such S1-S5 markings and of their position. No documentation has been found instructing SEA to enforce the decision and to activate the placement (painting) of the markings.

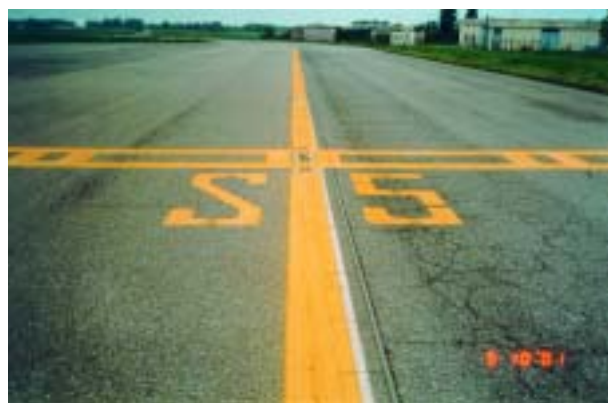
Photograph 10 - S5 marking and ICAO pattern B runway - holding.

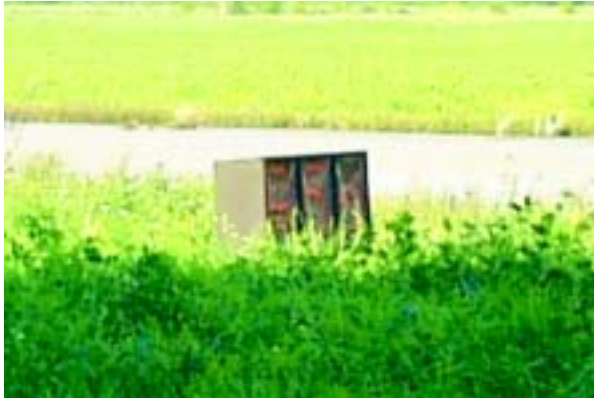
Photograph 11 - Location sign at TWY R5 entrance (exiting West apron).

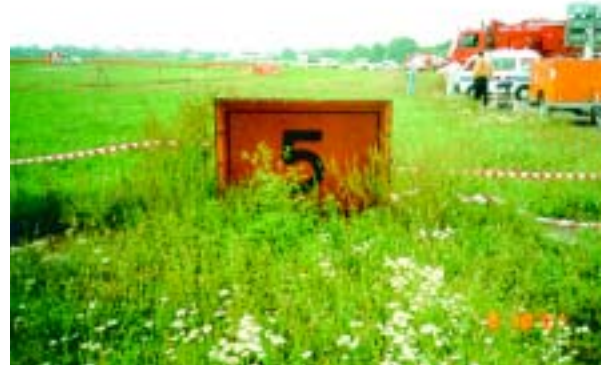
Taxiing from the North apron towards TWY R5, a vertical non illuminating location sign showed the indication **5** in black on red background to the left of the taxiway. This sign was partially covered with tall grass growing in front of it (see photograph 12).

Photograph 12 - Location sign at TWY R5 entrance (exiting North apron).

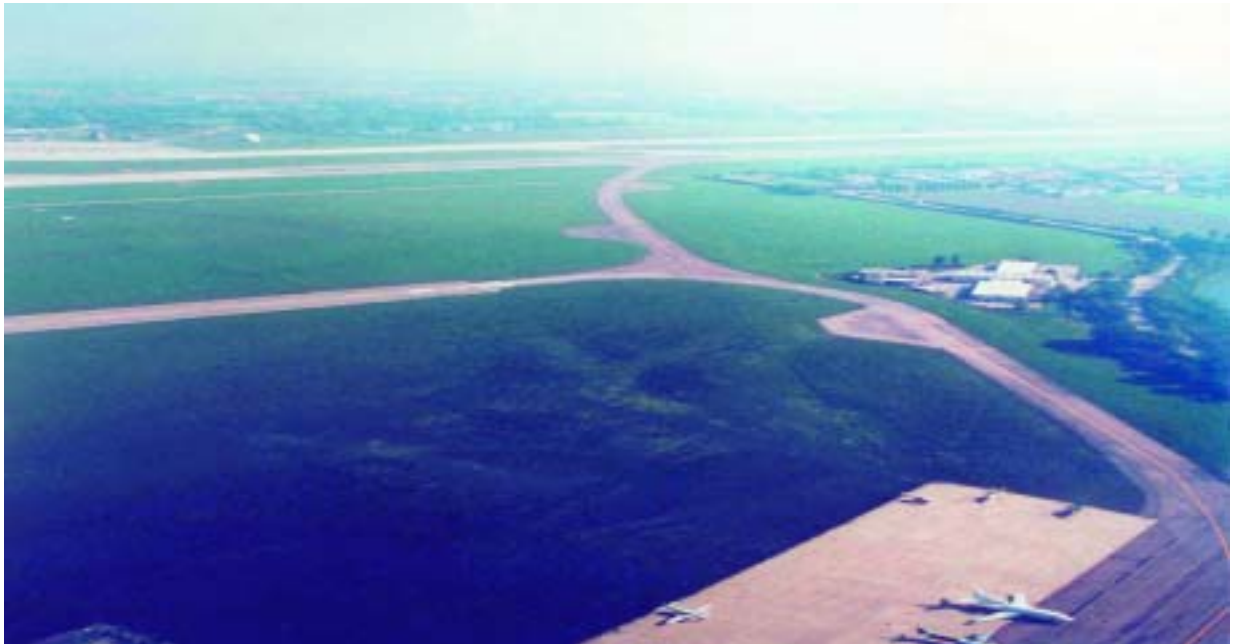
- c) the alphanumeric markings at the partition point, were the yellow line exited the parking position in front the ATA hangar, leading to R5 or R6, were not in conformity with ICAO Annex 14 (Chapter 5.2.16.4.b);
- d) the markings were partially worn and positioned at an angle (slanted) from the pilots' perspective, they could be confused with each other;

Photograph 14 - West apron aerial photograph (lower side).

- e) there was no vertical signage supporting the horizontal markings;
- f) South of RWY 18R, on TWY R6, the two horizontal markings **S4** and **S5** with holding-position markings ICAO pattern B, were not shown in AIP Italy or in the Jeppesen charts;
